## BROTHER® HL-2130 • TN410

### TONER CARTRIDGE REMANUFACTURING INSTRUCTIONS

# REMANUFACTURING THE BROTHER HL-2130/DCP-7055 (TN410) TONER CARTRIDGE

#### By Enrique Stura, Mike Josiah, and the Technical Staff at UniNet

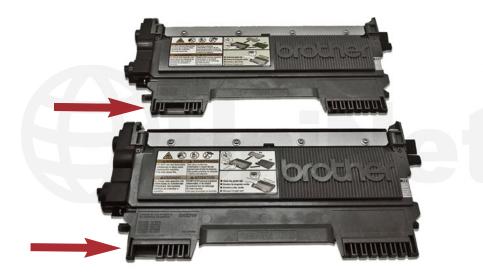
Difference between the TN410 (upper cartridge) and TN420 (lower cartridge)

At first glance, the TN410 and TN420 starter cartridges look identical, except for some changes to the cylinder heads for both, which impede or jam the closing of the printer lid in each case. As previously mentioned, the OPC drum unit for the DR420 is the same for both cartridges, as well as for TN450.

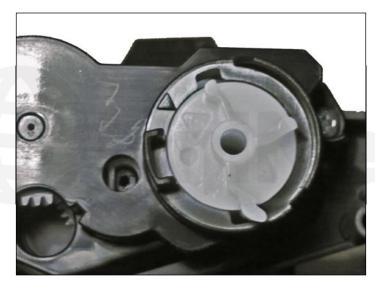
There is a reset gear that resets the machine's counters every time a new toner cartridge is installed. In order utilize the TN410 starter cartridge again, a special gear (called a flag gear) must be installed, and the left side must also be replaced with one that shows three actuator flags on it.

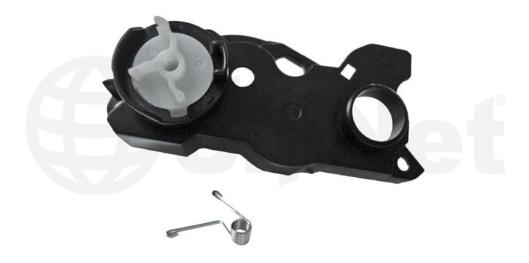
Flag gear, spring, and end cap shown for TN410 and TN420

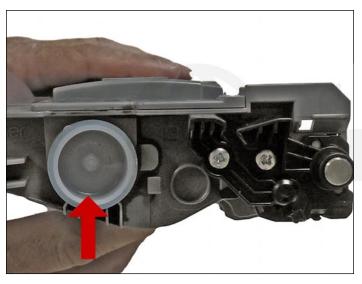
1. Vacuum the exterior of the cartridge. Remove the fill plug from the toner cartridge. Dump of the remaining toner and vacuum/blow out the cartridge.

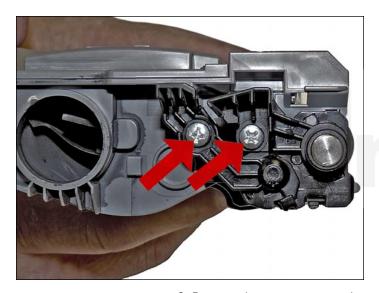
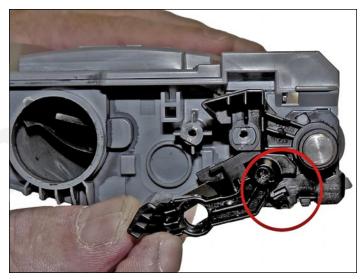
2. Remove the two screws on the non-gear side of the developer roller.

Remove the two plastic arms shown.

The smaller arm must be turned in order to release the lock.

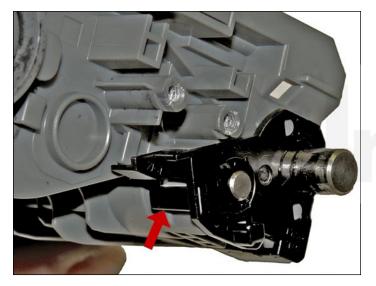
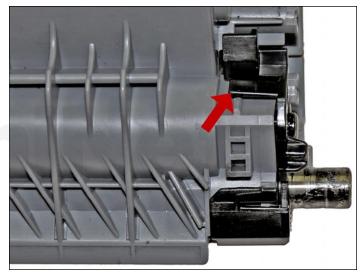
3. Remove the drum axle plate, lifting it up by the two tabs as indicated.

Lift the plate and take it out.

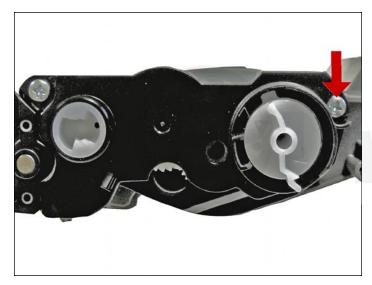
4. On the gear side, remove the two screws and cover plate.

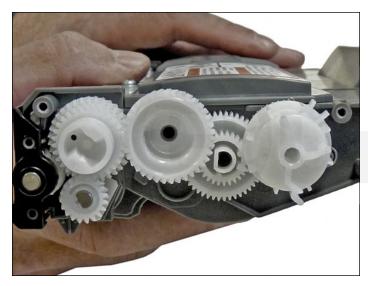
5. The reset gear is spring-loaded and must be positioned correctly for the printer to accept a new cartridge. The starter cartridge does not have a reset gear and the end cap blocked us from adding a new one. Starter cartridges will need to have a reset gear and replacement end cap before they can be used.

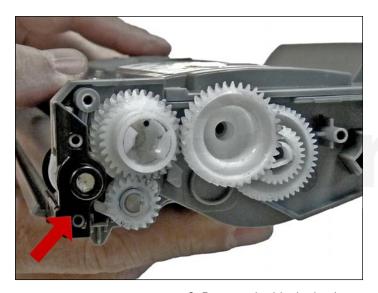
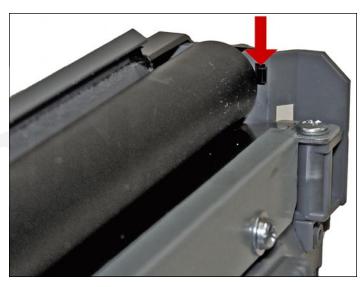
6. Remove the black plastic spacer from the developer roller shaft.

Press in on the black tab to release.

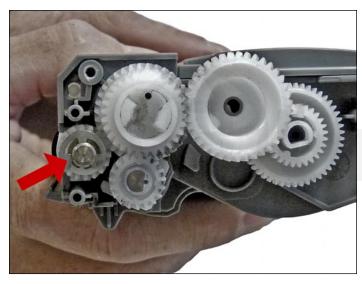
7. Remove the "E" ring.

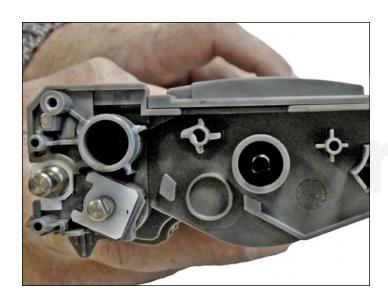
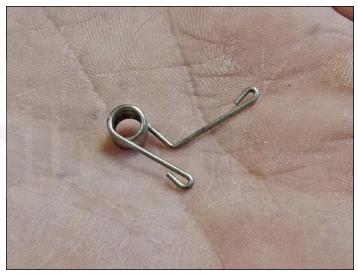
8. Remove all of the remaining gears.

Do not lose the reset gear spring!

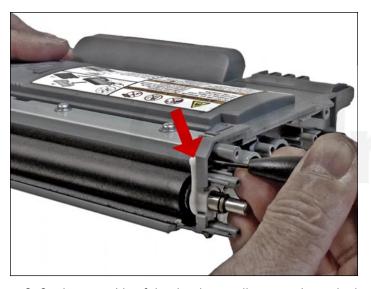
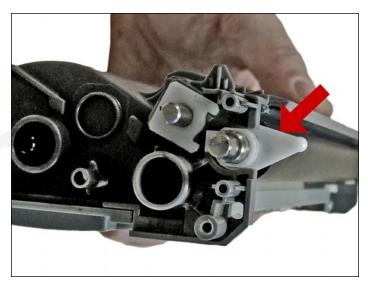
9. On the gear side of the developer roller, press in on the locking tab, and rotate the developer roller lock up, to release it.

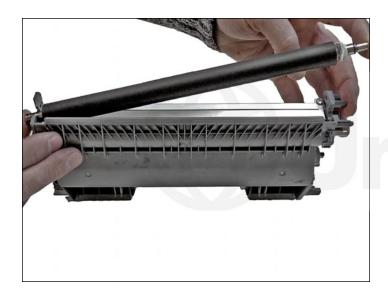
10. Remove the developer roller.

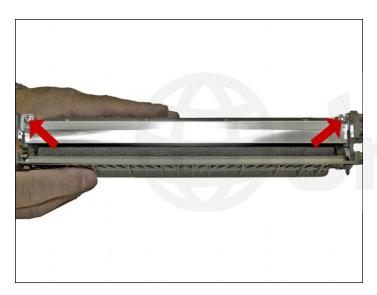
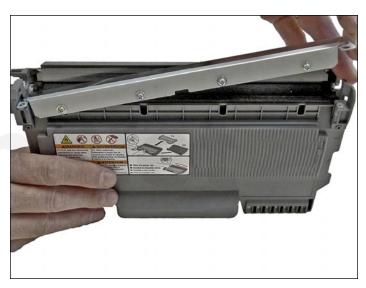
11. Remove the doctor blade screws and the doctor blade.

Unlike previous TN cartridges, the doctor blade is not physically attached to the seals, so it can be removed for cleaning.

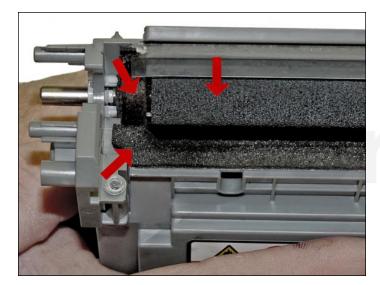
12. Completely remove all remaining toner from the toner hopper, the foam feed-roller, and the doctor blade foam seals.

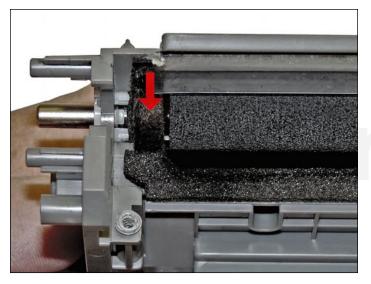
13. Inspect the magnetic roller felts. If they are compressed (shiny), rough them up with a small jeweler's screwdriver.

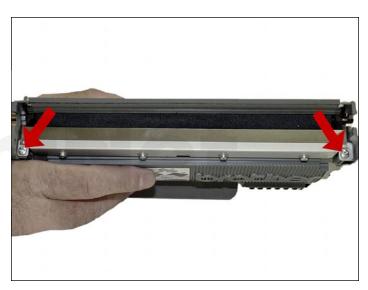
14. Carefully wipe the doctor blade down with a lint-free cloth.
Be careful not to bend or damage the blade in any way.

Install the blade and two screws.

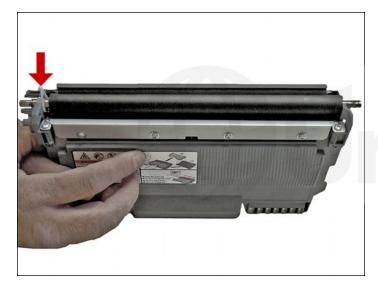
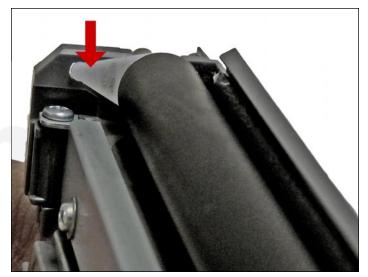
15. Clean the developer roller with a lint-free cloth and a dedicated developer roller cleaner for use on Brother rollers. Do not use any chemicals other than a dedicated Brother roller cleaner. Reinstall the developer roller (long shaft side to the gear side), with the white lock pointing up. Turn the lock towards the doctor blade until it locks in place.

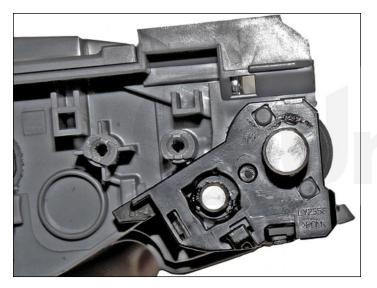
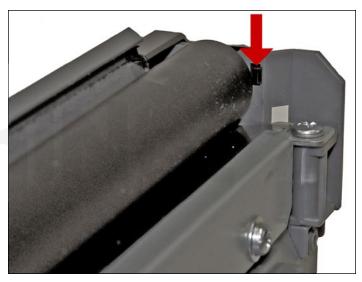
16. Install the non-gear side axle plate.

Make sure the tabs lock in place.

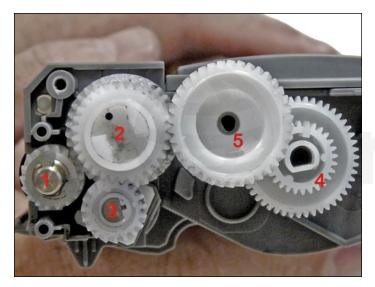
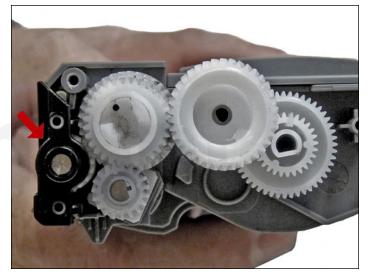
17. Clean the gears, making sure they have no toner on them. This is a good time to also check the gear shafts to make sure there is enough grease. If the shafts appear dry, or the grease is contaminated with toner, clean the shaft and inside the gear. Replace the grease with white lithium grease. Install the developer roller gear, "E" ring, black axle spacer, and the rest of the gears in the order shown. Make sure all the gears are meshing properly.

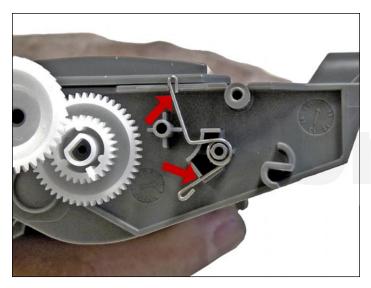
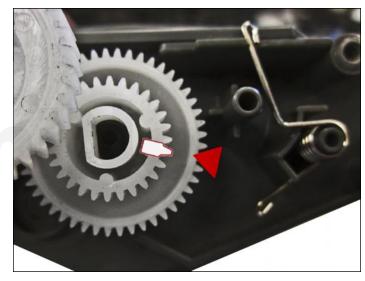
18. Set the reset gear spring as shown.

Ensure that the actuator gear is in the proper position as shown (right photo).

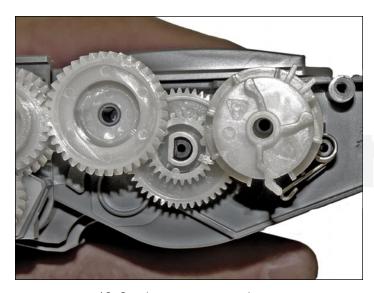
19. Set the reset gear as shown.

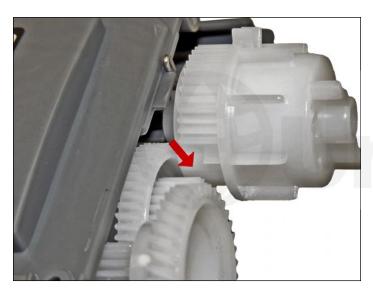
Note that the gear teeth are not meshed when set, which is how it should be. The gear is spring-loaded and will turn when driven by the printer.

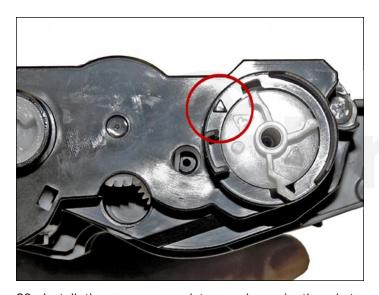
20. Install the gear cover plate as shown in the photo. Make sure the black arrow on the cover is aligned with the white arrow marked #3. This applies both to the TN410 and the TN420 cartridges. This is not the case for the TN450, which has different gears.

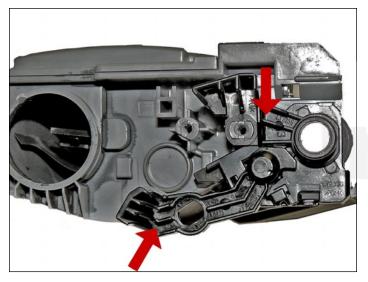
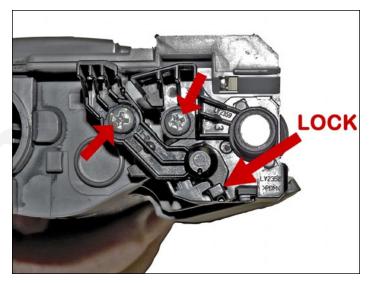
21. On non-gear side, install the plastic arms and their corresponding screws.

The smaller arm is installed last, and must be turned from the bottom up, so that the lock engages.

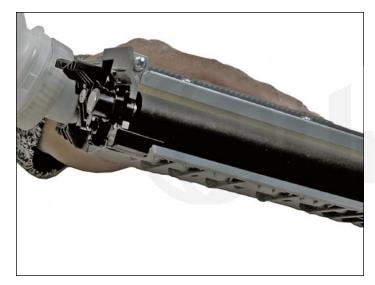
22. Fill the cartridge with the proper gram load of black toner for use in the Brother TN410 cartridge (approximately 45 grams).

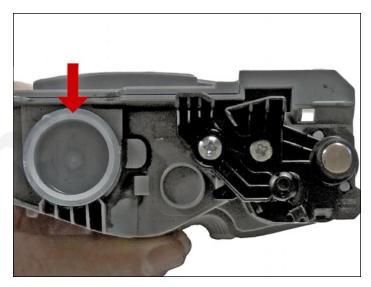
23. Replace the fill plug.

Wipe the cartridge down to remove any toner dust.

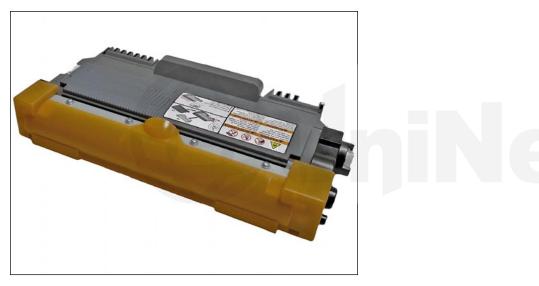
24. Install the developer roller cover.

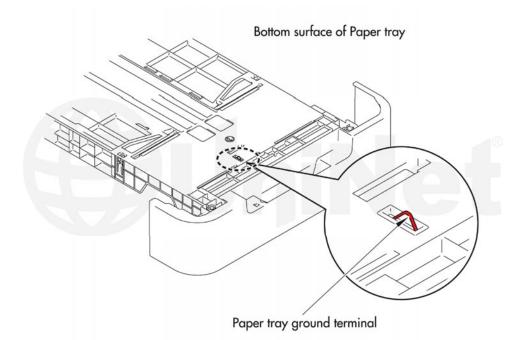
#### REPETITIVE DEFECT CHART

OPC drum: 94.2 mm
Upper fuser roller: 53.4 mm
Lower pressure roller: 78.5 mm
Developer roller: 32.5 mm

**NOTE**: If you are experiencing horizontal black streaks and changing cartridges does not help, look to the bottom of the paper tray. There is a small metal ground terminal. If it gets bent or dirty, it can cause this.
